Safety Audits and Walking Assessments around Bus Terminals in Delhi

November, 2018

Report prepared by ITDP

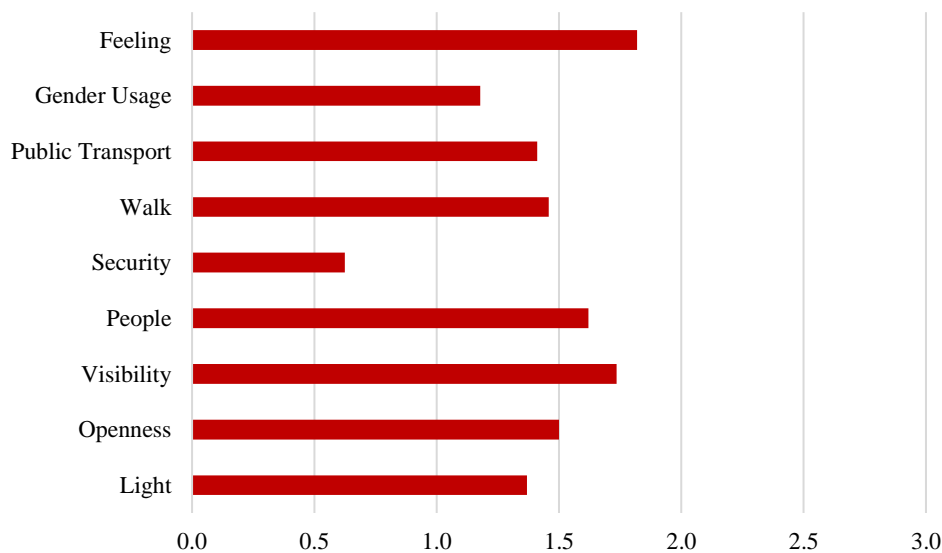
Figure 2: Average rating of parameters across all bus terminals

A comparison of the average scores of the 2,595 audits does not present an optimistic picture. All of the parameters scored below two, indicating that the feeder areas around public transport terminals are not inviting public spaces for women and girls. As far as walking facilities, public transport infrastructure, clear sightlines, presence of people, and gender diversity are concerned they were found to be sub-optimal. Security scored an abysmal 0.6, which indicates a low presence of security personnel (whether guards or police), who could be called upon for help or in the case of an emergency. A gender usage score of 1.2 reveals that the existing streets have low gender diversity. An overall score of 1.8 for the feeling of safety could be attributed to the surveys being conducted during the daytime.

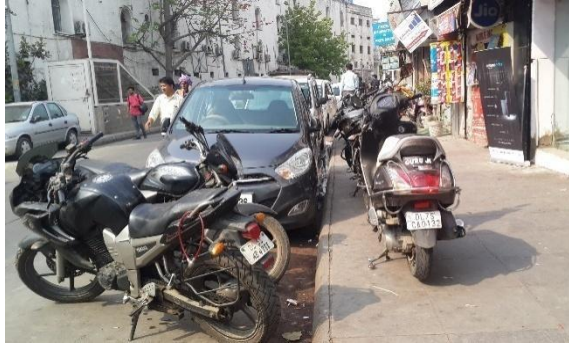
Image 4: Encroachment by parking near Shivaji Stadium terminal

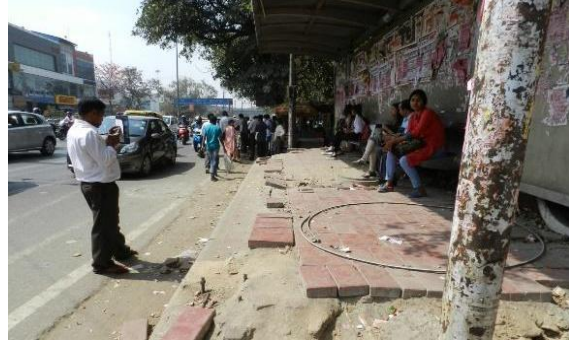
Image 5: Broken footpath at Kirti Nagar bus shelter

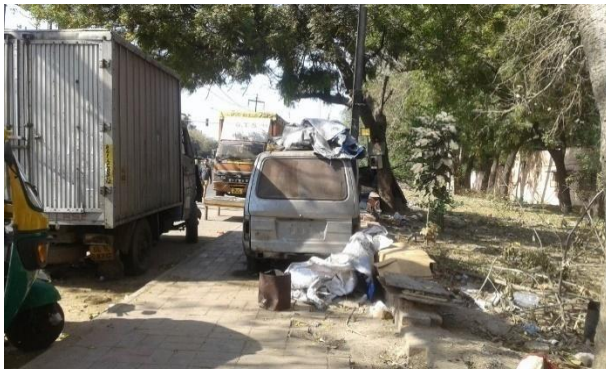
Image 12: Parked vehicles and encroachment on footpath reducing the openness around Kalkaji bus terminal

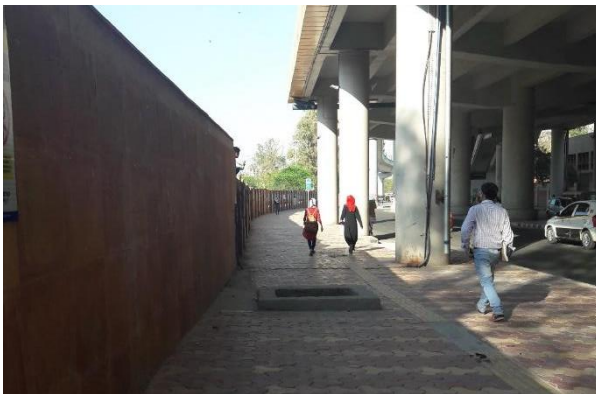
Image 14: High boundary walls reduce visibility near Jamia Islamia metro station

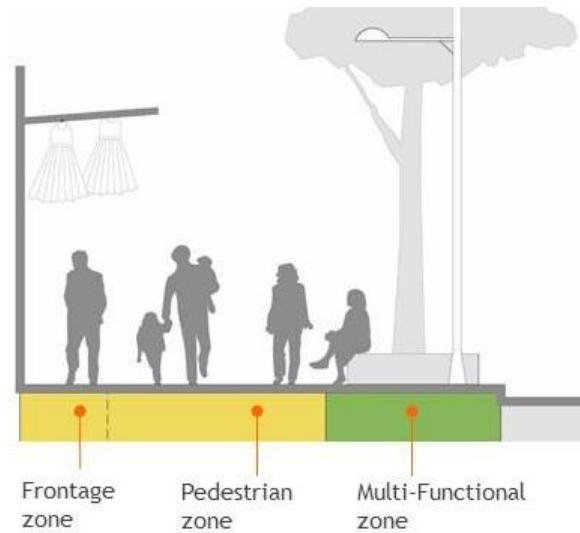
Figure 16: Typical footpath section

The IRC standards that urban footpaths need to adhere to:

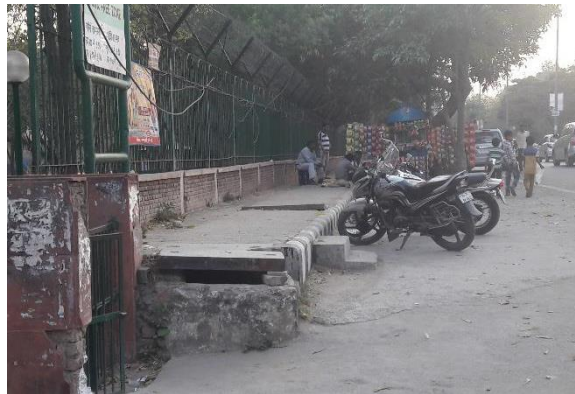
Image 21: Inaccessible footpath height

- A clear height of 2.4m, free of any obstacles, should be maintained along the width of the pedestrian zone to ensure visibility, openness, and continuous walking experience.
- Footpath surface should be evenly paved to ensure convenience, particularly for those on wheelchairs.

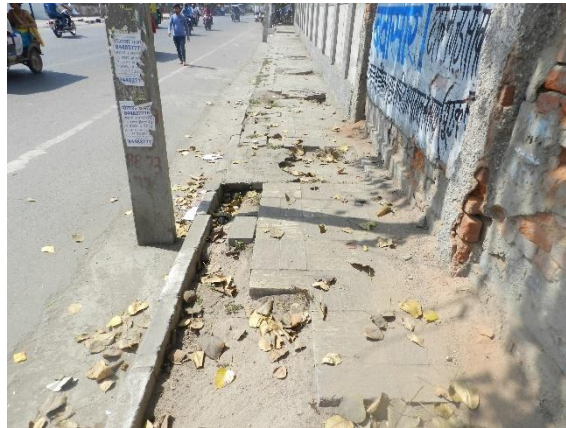
Image 22: Poor footpath surface

- To offer accessibility to all users, the concerned road owning agency should ensure that footpaths and other elements of the pedestrian environment are in compliance with the Ministry of Urban Development's Harmonised Guidelines and Space Standards for Barrier-Free Built Environment for persons with Disability and Elderly Persons (2016).

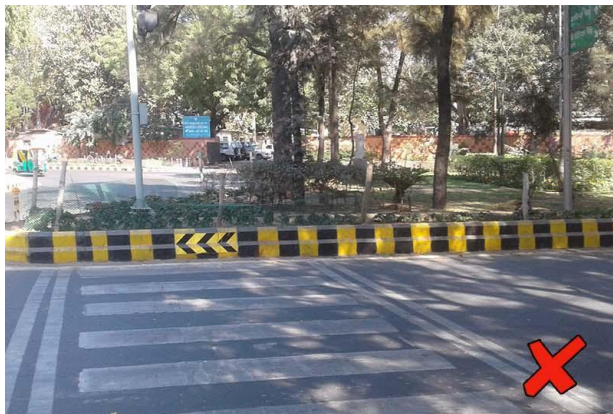
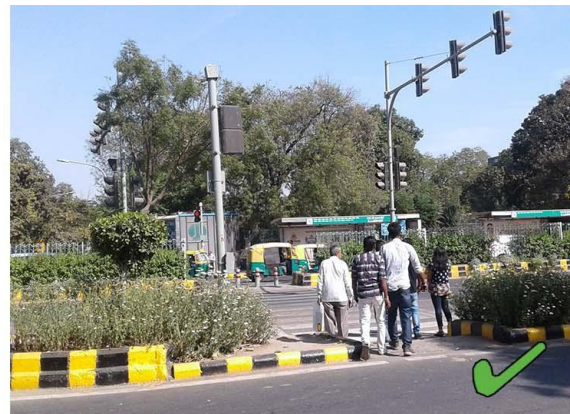
Image 25: Inaccessible crossing around Safdarjung terminal (L); A good example of crossing (R)

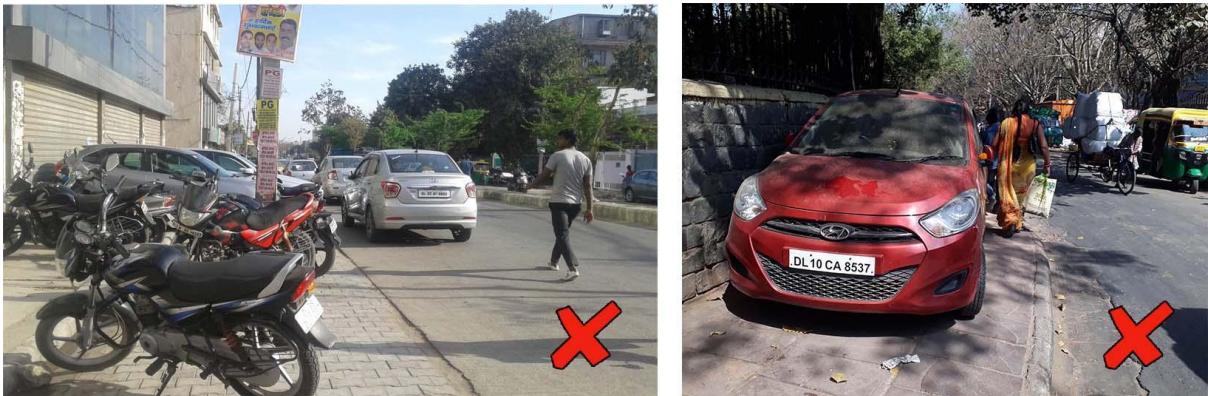
It was found that continuous and unregulated on-street parking, either on the footpath or along the curb side, forces pedestrians to walk on the carriageway. The perpendicular orientation of parking occupies about 30-40% of the right-of-way leaving little space for footpaths. The provision of on-street parking should follow the below guidelines and standards.

Image 26: Parking encroachment on footpaths

- On-street parking should be provided only after creating sufficient space for pedestrians, non-motorised vehicles, public transport, and other facilities.
- On-street parking should be provided as per the hierarchy shown below:

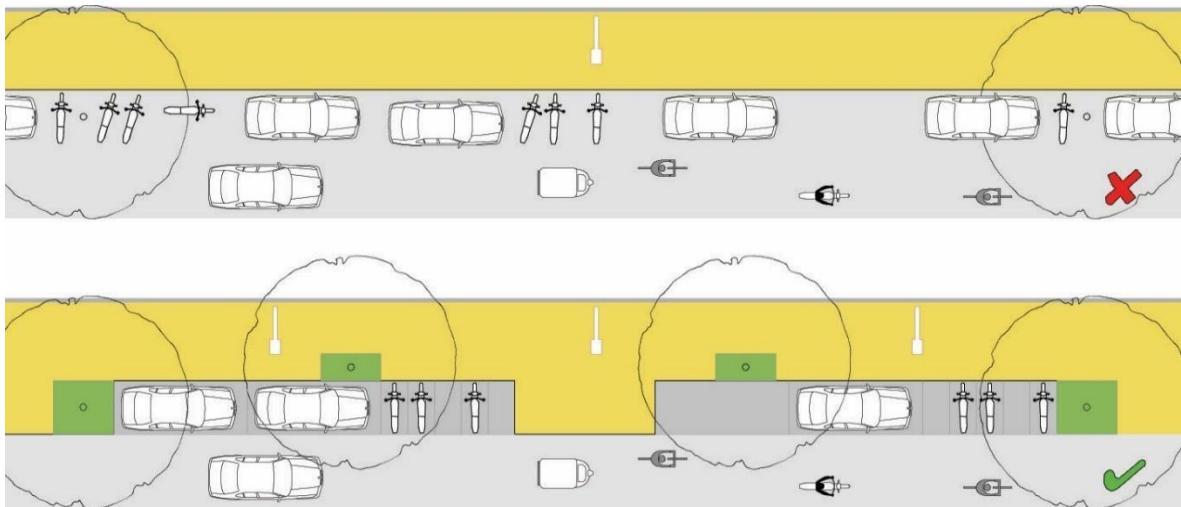
Figure 22: Recommended on-street parking design

- Unabated encroachment by parking affects the safety of an individual, as it reduces visual connectivity and prevents pedestrian access to footpaths. Often these spaces become urination spots for men, gambling activities, and other anti-social activities. Parking bays should be spaced with bulb-outs, tree pits, and other street amenities. Bulb-outs should be provided after every four to five car parking spaces, to enable frequent opportunities for pedestrians to exit and enter the footpath. Parking bays should also be marked to ensure proper parking.

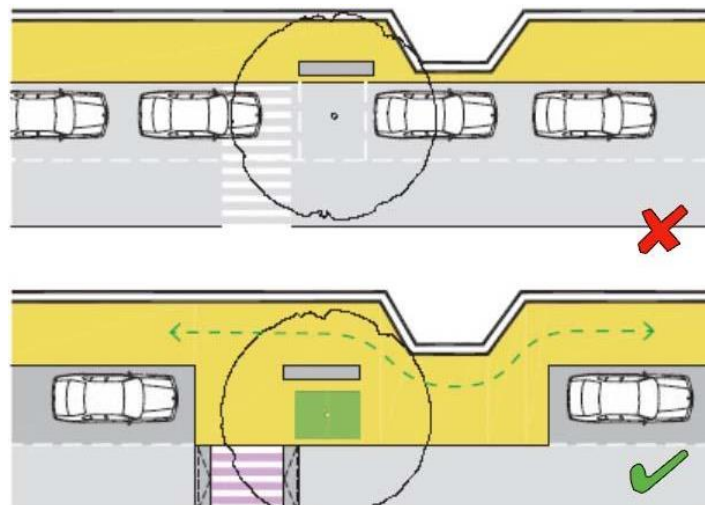
Figure 23: On-street parking design at pedestrian crossing

- Avoid guard rails or similar features in parking bays to allow direct access to footpath from parking slots or the street.
- Parking should not be allowed at crosswalks, near bus stops, and intersections.

- On-street parking should be provided 50m away from the intersection of arterial roads. At the intersections of collector and local streets, on-street parking can be provided after two parking spaces from the stop line away from the intersection as shown in *Figure 23*.

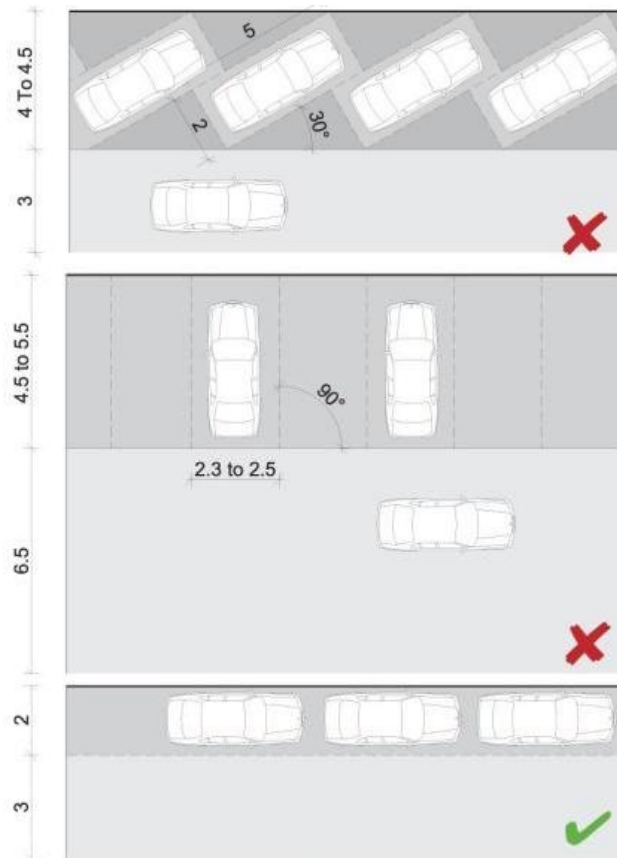
Figure 24: Recommended orientation for on-street parking

- On-street parking, for three- and four-wheelers, should only be allowed in the parallel format as angular and perpendicular parking occupy a large portion of the right-of-way. Also, exiting angular and perpendicular parking bays can be dangerous because drivers have limited visibility. It also disturbs the traffic flow and leads to congestion. Perpendicular parking configuration can be considered for bicycles and motorised two-wheelers.

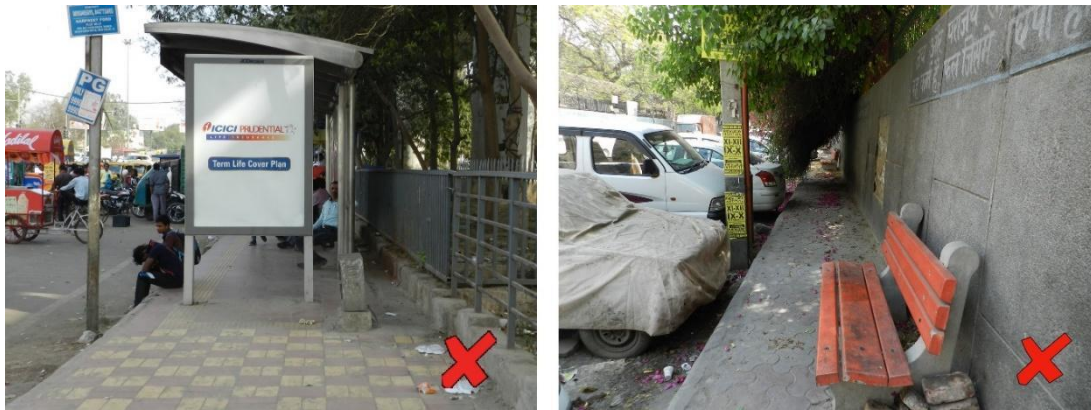
As is established, visually open streets and public spaces help in increasing the safety of an individual. Based on our field studies, it was observed that perpendicular advertisement boards on bus stop, continuous line of parking, and encroachment of utilities on footpath reduced the openness. These are our recommendations to improve upon the visibility on footpaths and bus stops:

Image 28: Street elements blocking the vision

- Continuous on-street parking should be avoided. It creates dark spots and reduces visual connectivity especially where heavy vehicles are parked. Parking bays should be spaced with bulb-outs, tree pits, and other street amenities.

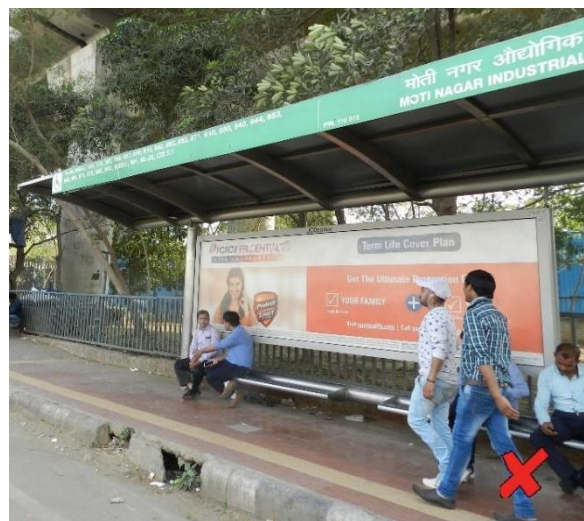
Image 29: Opaque back panel of the bus stop reduces openness

- Signages, street amenities, or advertisements should not impede an individual's visibility. It is recommended to maintain a clear height of 2.4m below the signages to ensure pedestrian visibility.
- The back panel of the bus stop should be transparent or open, to ensure safety of an individual waiting at the bus stop. Often the space behind the bus stop is a blind spot which can create a feeling of insecurity.
