# Situational Analysis of Chennai Streets

Chennai | 2025

**PREPARED BY ITDP India**

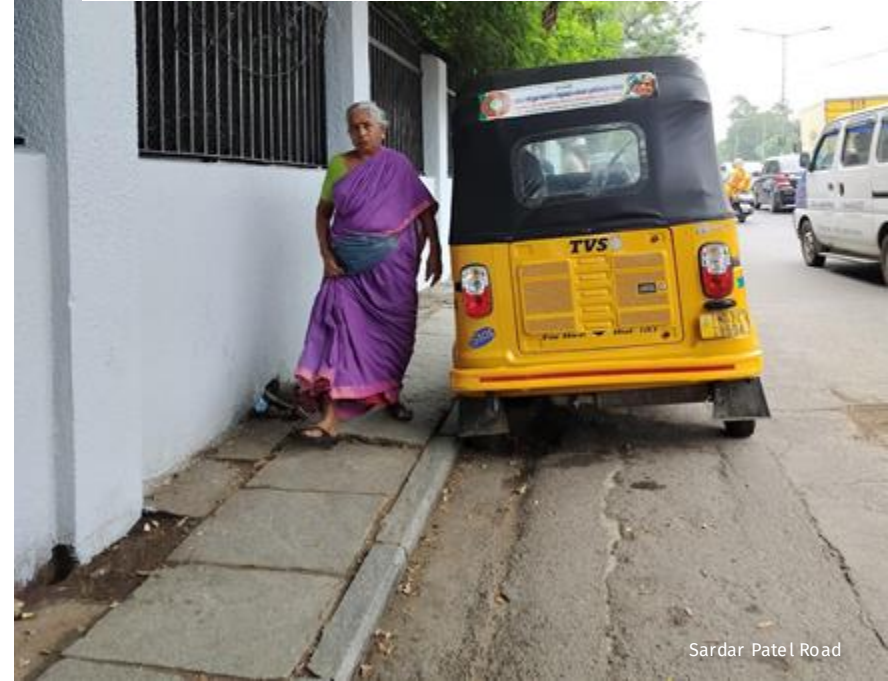
## Adequate Pedestrian Zone

**55% of footpaths** across all streets was found to have **inadequate width**.

**40%** of the total length of all streets **did not** have any footpath infrastructure.

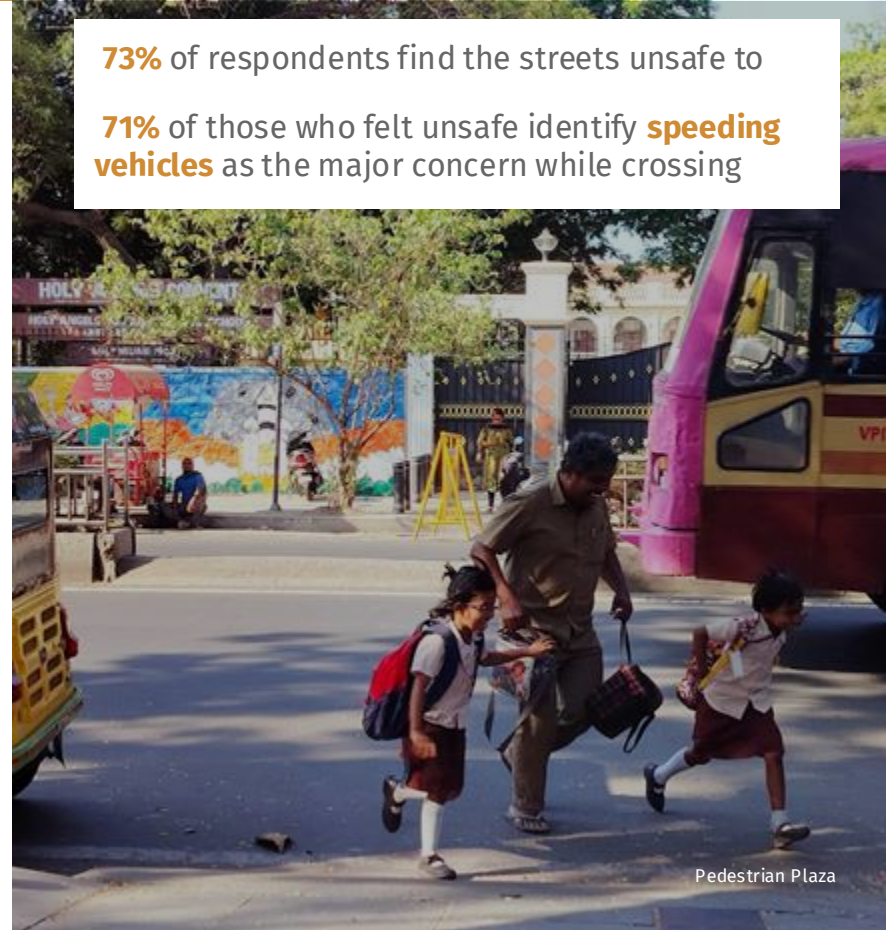
## Concerns of Safety on Streets

73% of respondents find the streets unsafe to

71% of those who felt unsafe identify **speeding vehicles** as the major concern while crossing

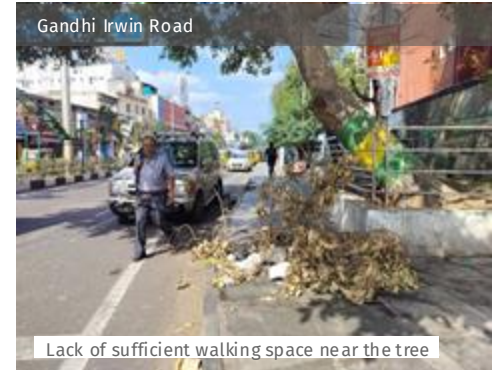
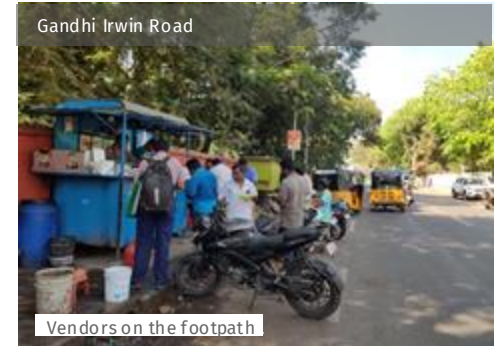
**Absence of an enforcement/Operation and Maintenance framework** results in **footpath encroachment and diminishing of clear walking zones** for pedestrians. Streets that otherwise perform fairly such as **Old Jail Road, Thirumalai Pillai, Gandhi Irwin, and Thiru Vi Ka High Road** illustrate this issue.

**Enforcement:** As observed earlier, vehicular and vending encroachment has been biggest deterrent for ease of movement. Vehicular and vending enforcement needs to be done on priority to ensure good streets.
