Public transport and NMT infrastructure assessment for Erode, Tamil Nadu

*Analysing 'People Near Transit' and
Existing Service Quality of Bus
Stops and Footpaths*

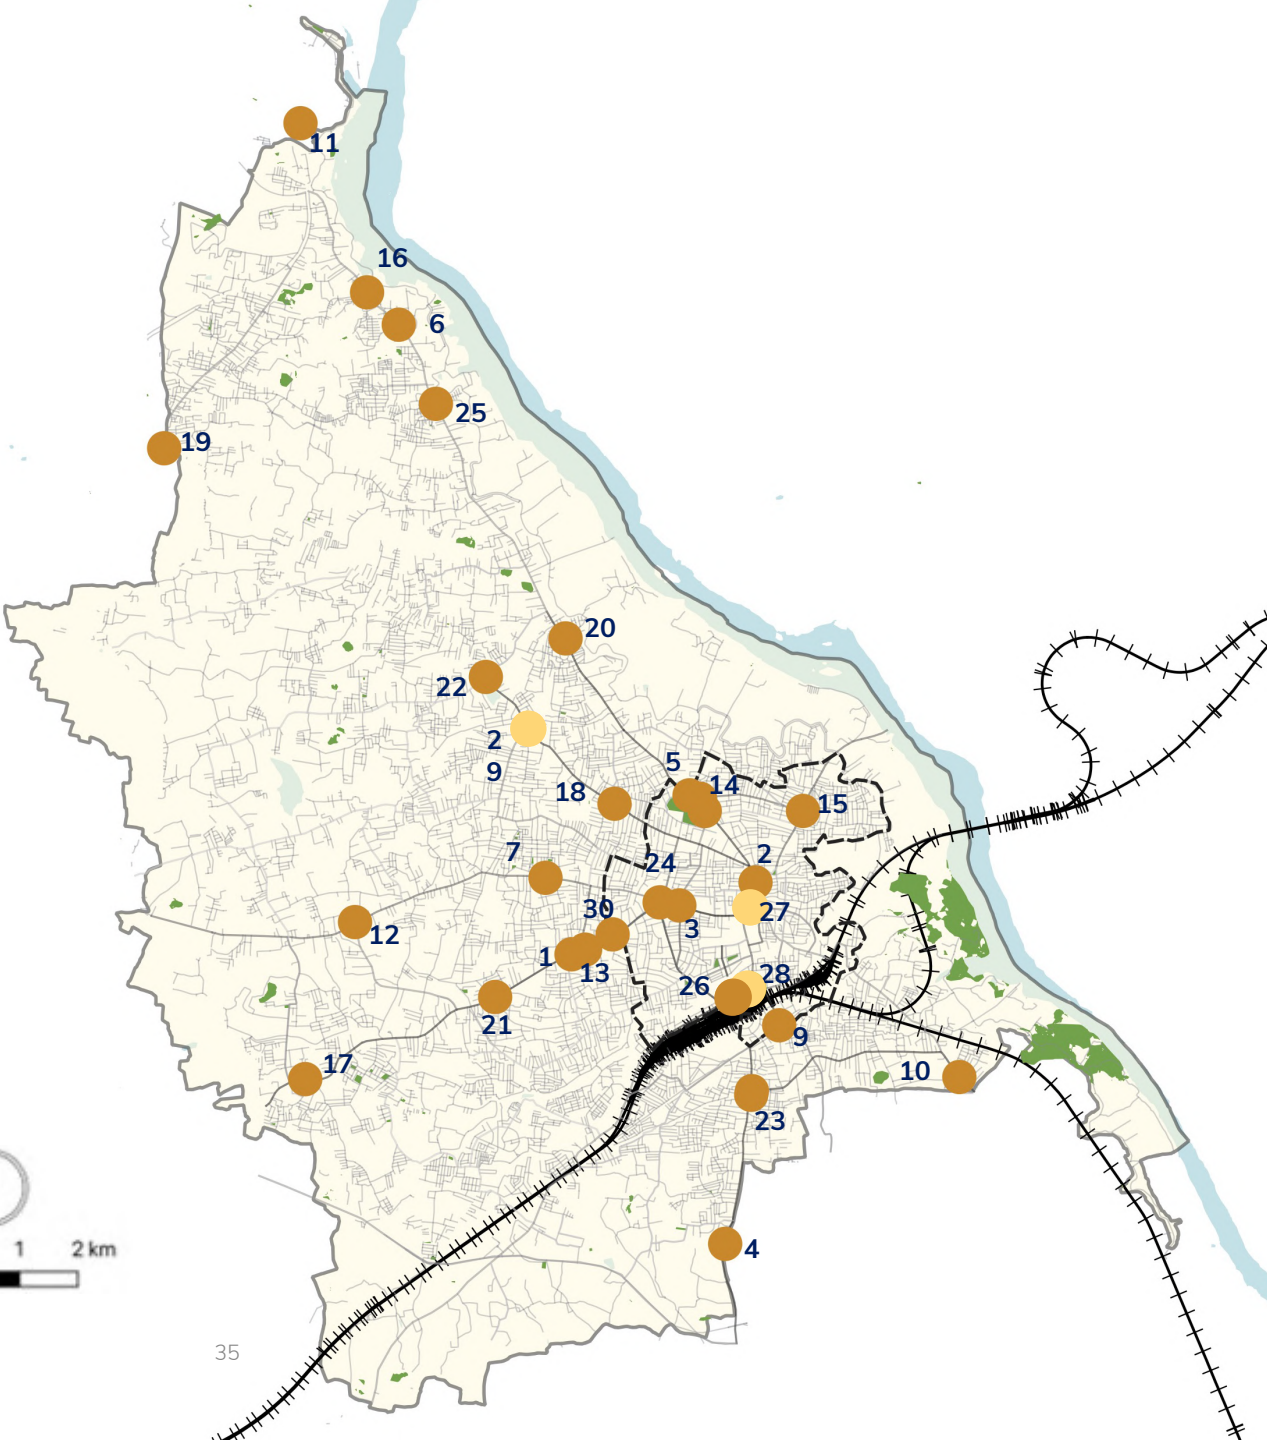
23 bus stops representing approximately 76% of the total number of surveyed bus stops lack adequate facilities, indicating a significant need for infrastructure improvement across the network.

S No	Name	Score
1	Teachers colony	2
2	Manikoonda	2
3	Savitha	2
4	Vaikal Medu	2
5	Moolapattarai	2
6	Mayavaram	2
7	Narayanavalasu	2
8	Annamar Bunk	3
9	Lotus Hospital	3
10	Solar	3
11	Sathyamoorthy Hospital	3
12	Lakshmi Nagar	3
13	Veerappampalayam Pirivu	3
14	Collectorate	4
15	VOC Park	4
16	Karungal Palayam	5
17	Perumalmalai	4
18	Thindal	5
19	Veerappanchatram	6
20	Chithode	5
21	Agraharam	5
22	Palayapalayam	5
23	Ganiravuthar Kulam	6
24	Petrol Bunk	6
25	Erode GH	6
26	Petrol Bunk	6
27	Railway Station	6
28	PS Park	7
29	Bull Fight Corner	9
30	Soolai	8

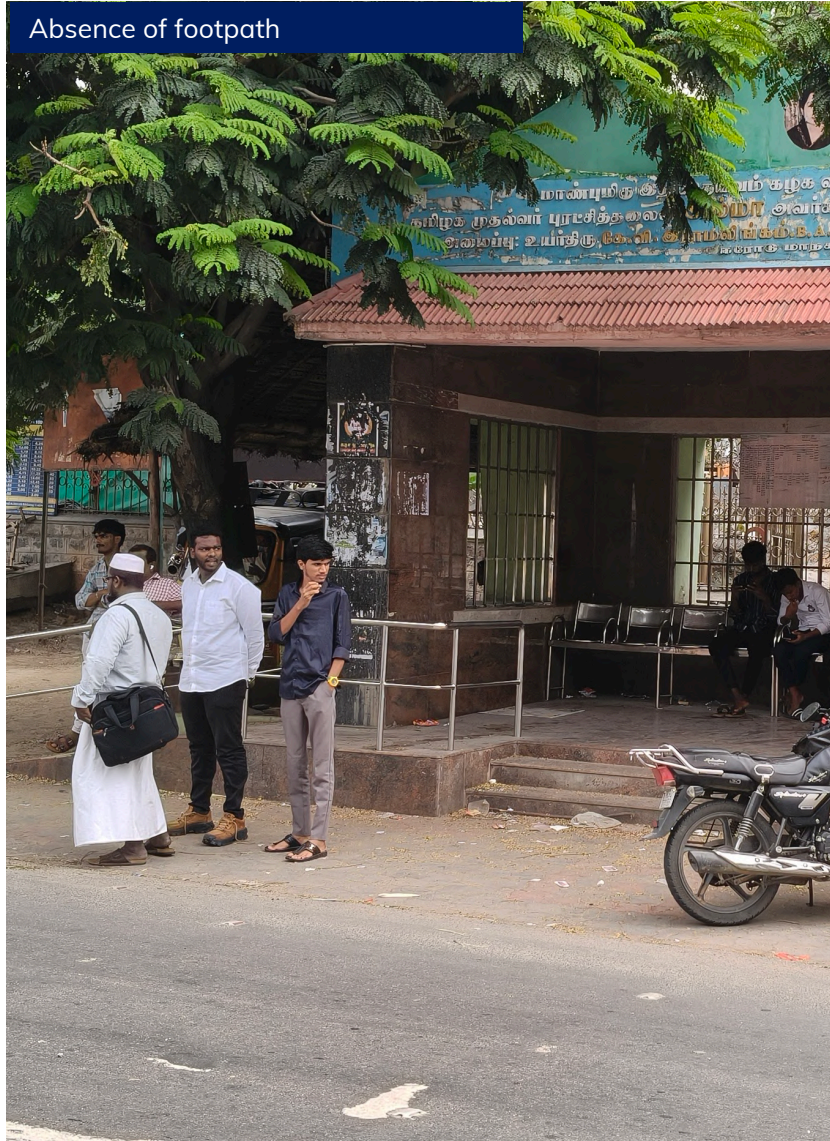
Access to bus stops is constrained, with 100% of bus stops encroached by vendors/parking on either side, and approximately 35% of respondents, who are aged 45–60, reporting challenges related to universal accessibility.

Absence of footpath

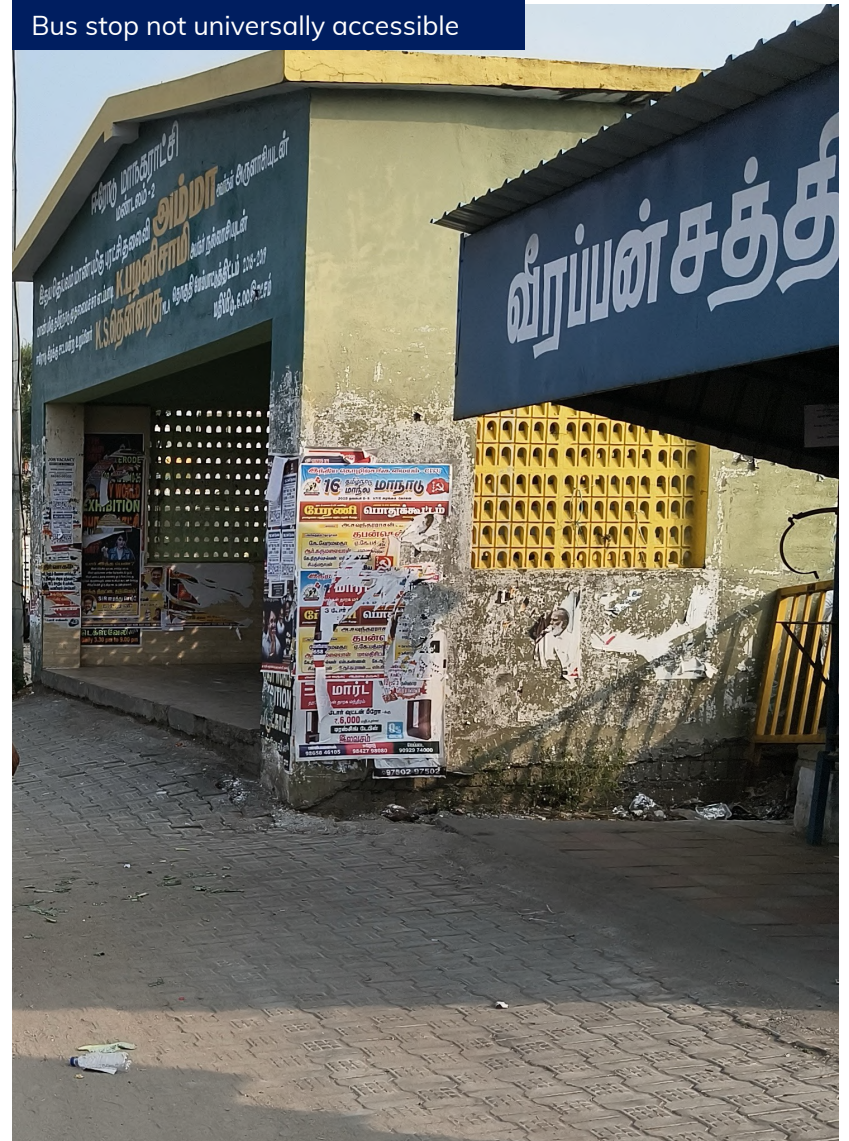
Bus stop not universally accessible

- Provide **seamless accessibility** by keeping the pavement of the bus shelter at the same level as the footpath.
- Ensure that all shelters **follow IRC norms**: a 0.15 m pavement height and a minimum 1.2 m width of waiting area. At present, the height of the shelter pavement is 0.4 m, which is unsafe as the steps negate wheelchair access, and also increase the risk of tripping.
- Develop **universally accessible designs**, along with expert input and review with relevant stakeholders.
- Provide **even, non-slippery surfaces** and **tactile paving** at both shelters and along the approach road, for the ease of visually impaired users.

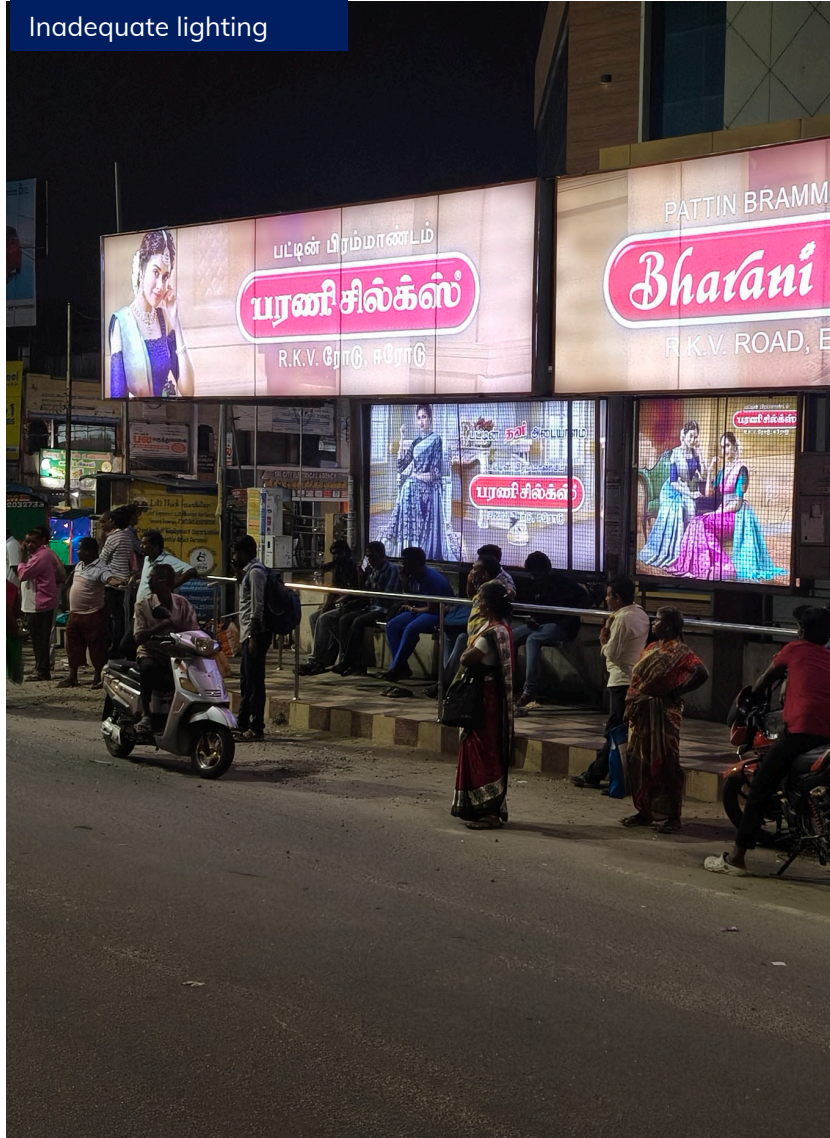
Audit findings reinforce these concerns. Nearly 57% of stops lack adequate lighting, almost none provide functional emergency information, and over 60% suffer from poor maintenance with hazardous dead spaces behind the stops.

Inadequate lighting

- Provide **uniform lighting of 30–40 lux** at shelters as per IRC standards to ensure safety and visibility. Presently, many bus stops rely on advertising panels or ambient street lighting, which is inadequate and compromising safety—especially for women and vulnerable users.

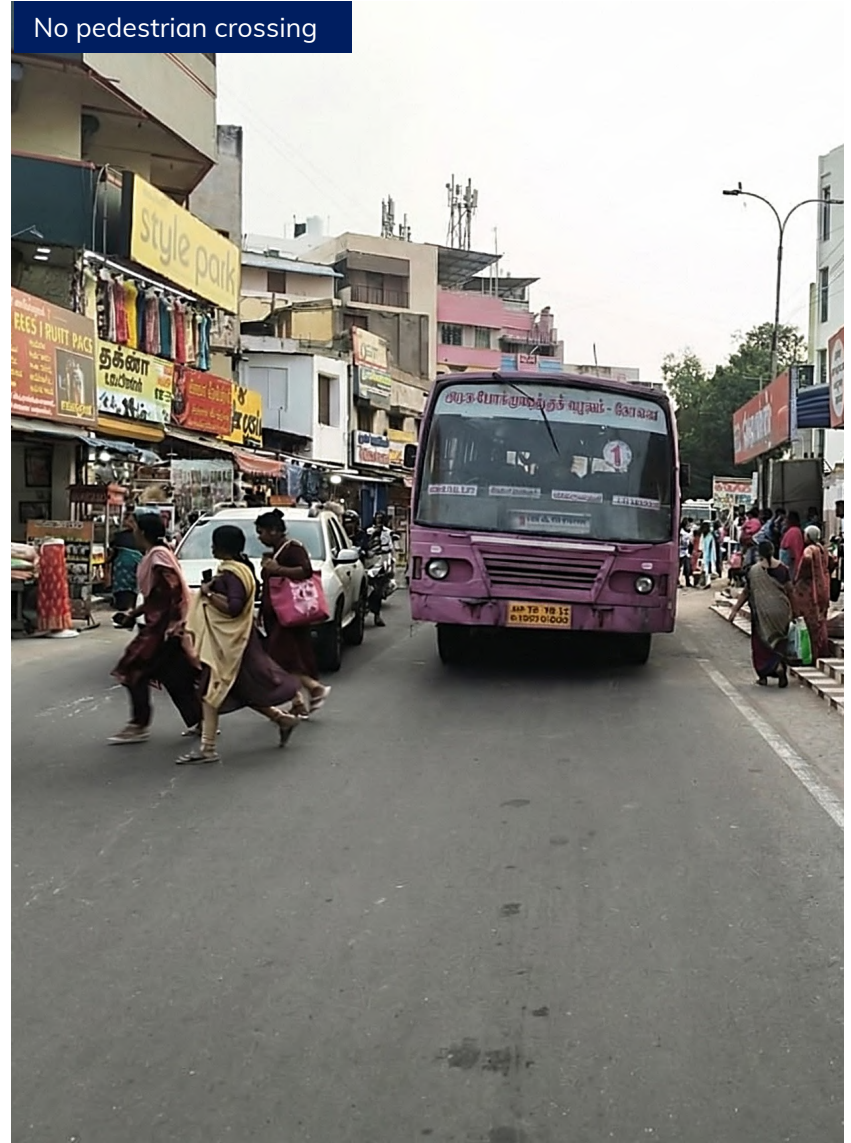
No pedestrian crossing

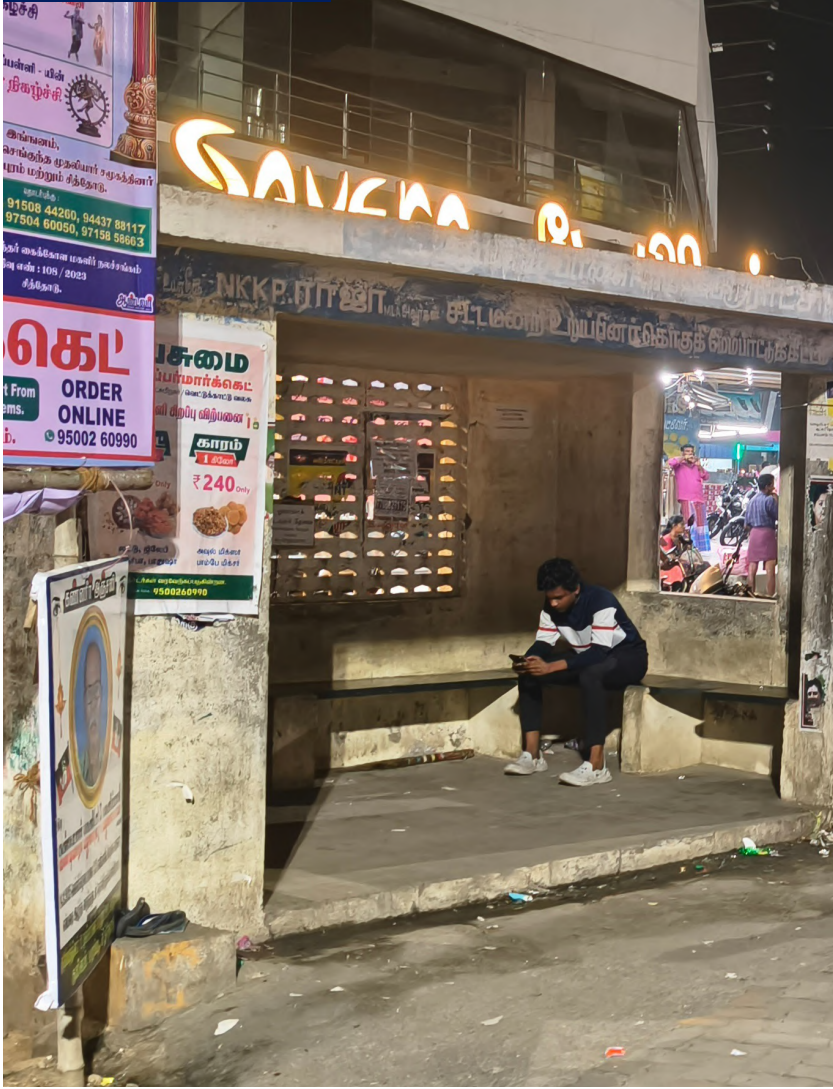
Basic commuter amenities are largely missing across bus stops. Nearly **92% of users** identify the **absence of seating** as a major issue, reflected in audit findings where **47% of shelters lack seating entirely**.

Inadequate seating

- Use sturdy poles and durable roofing to provide reliable weather protection for passengers.
- Conduct regular inspections to identify damage and ensure timely maintenance, keeping shelters safe and fully functional.
- Provide ergonomic seating with a height of 0.4–0.6 m to ensure comfort and accessibility.
- Avoid low or damaged seats, as they reduce usability and inconvenience passengers.
- Ensure regular maintenance so seating remains safe, functional, and user-friendly.

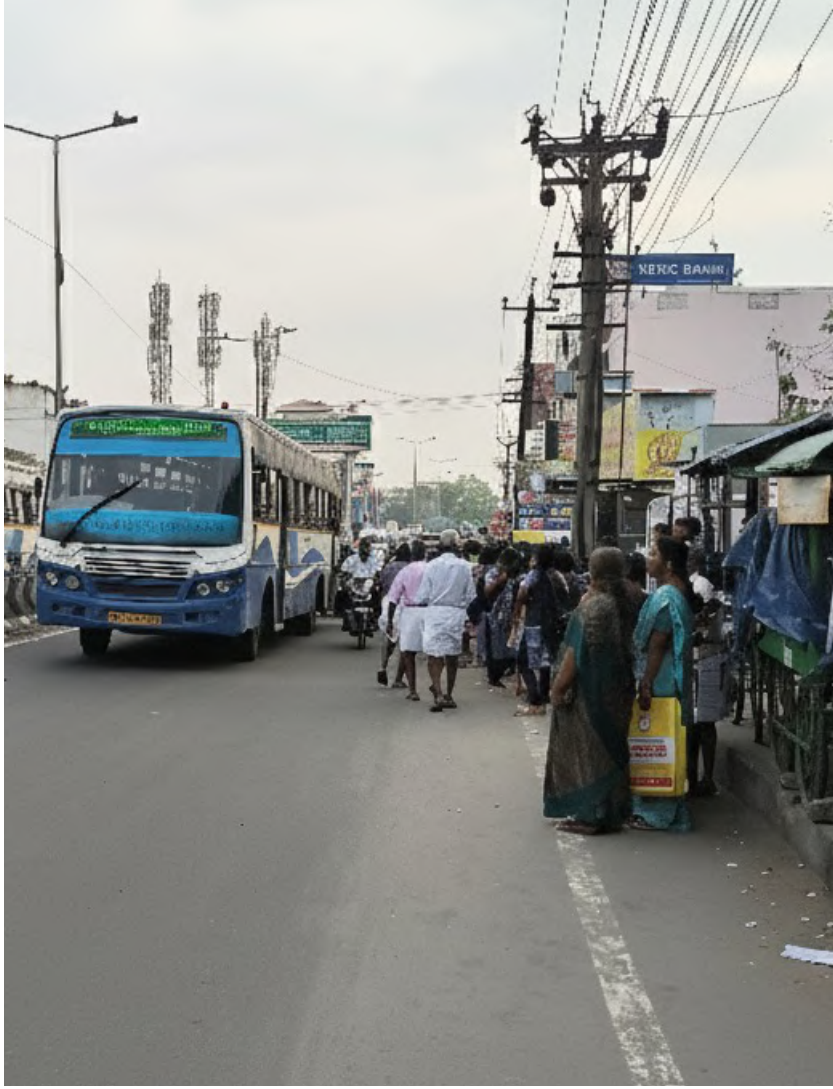
Most essential facilities, including proper shelter, roof, and seating, are absent in almost 80% of the bus stops. 56% of respondents raising these concerns are aged 18-25.

Absence of shelters

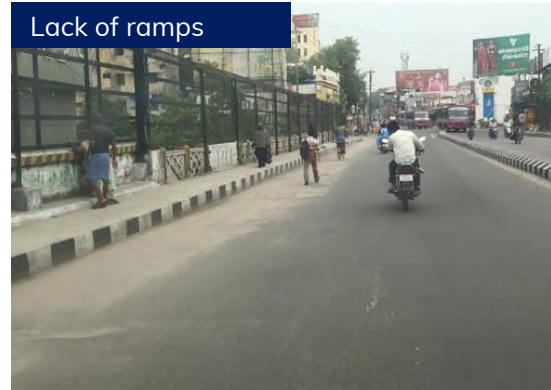
Lack of ramps

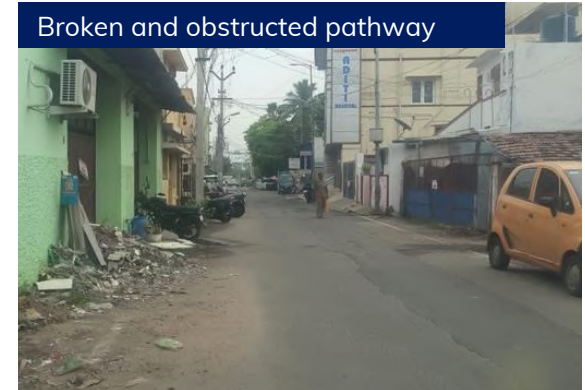
Street utilities, vendor encroachment, and parking were cited by most people (52% on average) as hindrance to walking. However, **uneven, slippery or broken footpath was the most highly cited reason (62% on average) for not using the footpath.**

Broken and obstructed pathway
